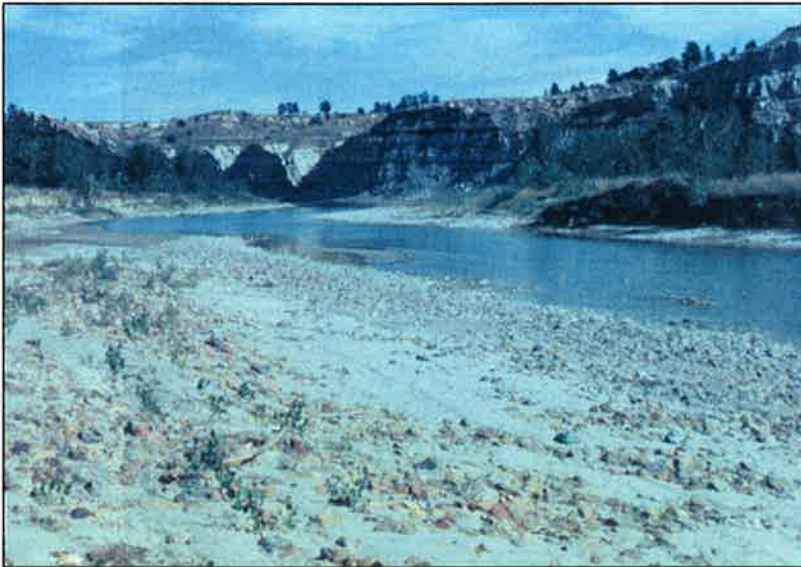
PR151.
7 September 1975.
View downriver
through section.

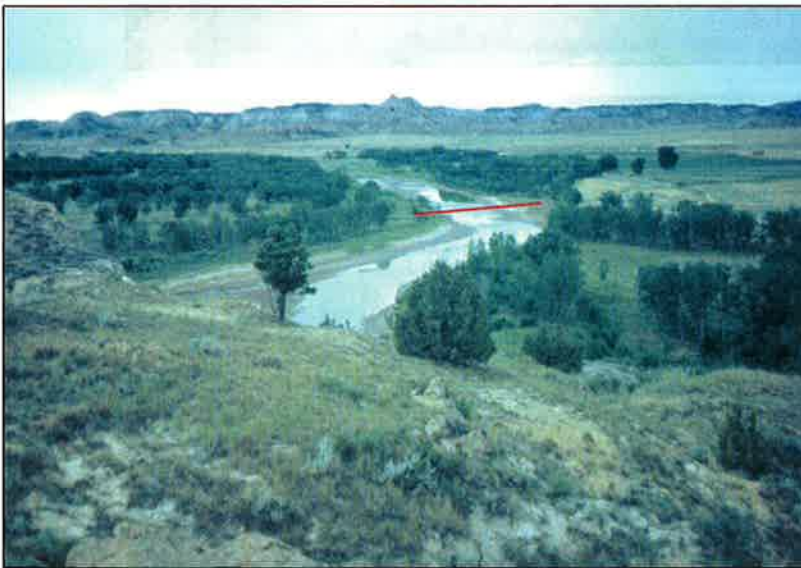
PR151.
23 July 1977.
View upriver. Red line
is approximately on
line of section.

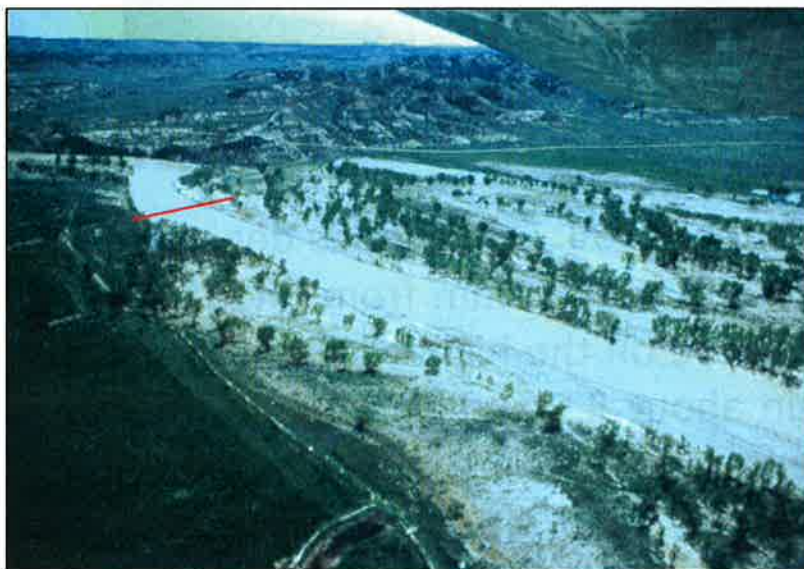
PR151. 25 May 1978.
Aerial view downriver
during waning stages of
the 1978 flood. Red
line is the approximate
line of section. White
areas show the extent
of sand newly
deposited by the flood
on floodplain and
terraces.

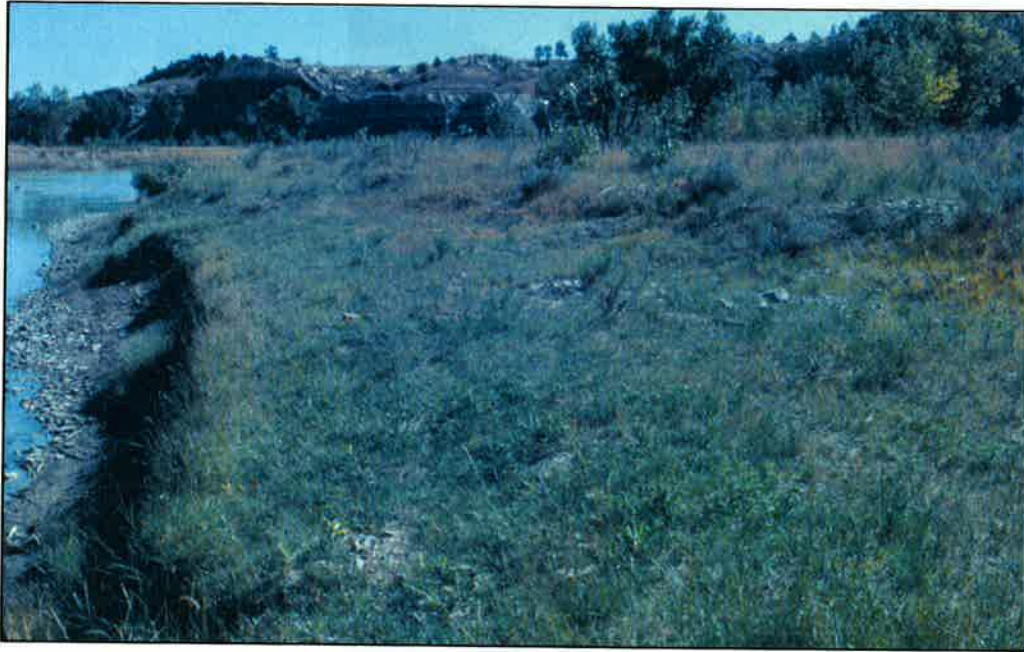
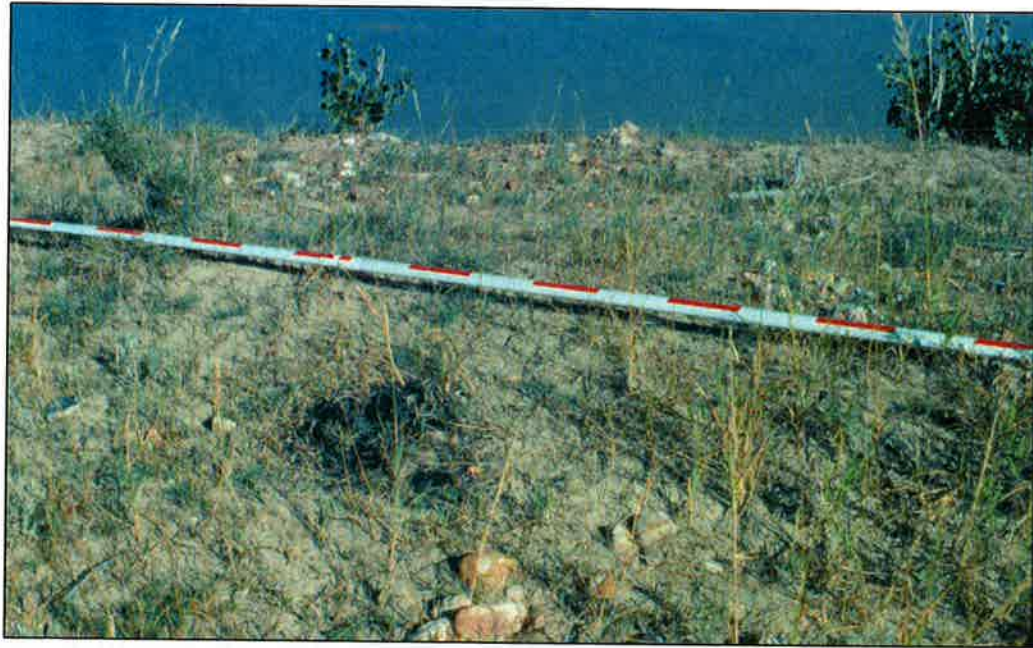
PR151. **Top.** 20 September 1994. Gravel pods deposited on the right bank about 100 m upstream from PR151 during an ice jam flood. Pods are on the higher Lightning terrace and on the floodplain about 2.5 and 3 m above the river bed. **Bottom.** 20 September 1994. Gravel pods about 30 m upstream from PR151 and about 3 m above the riverbed. One pod contains coal.

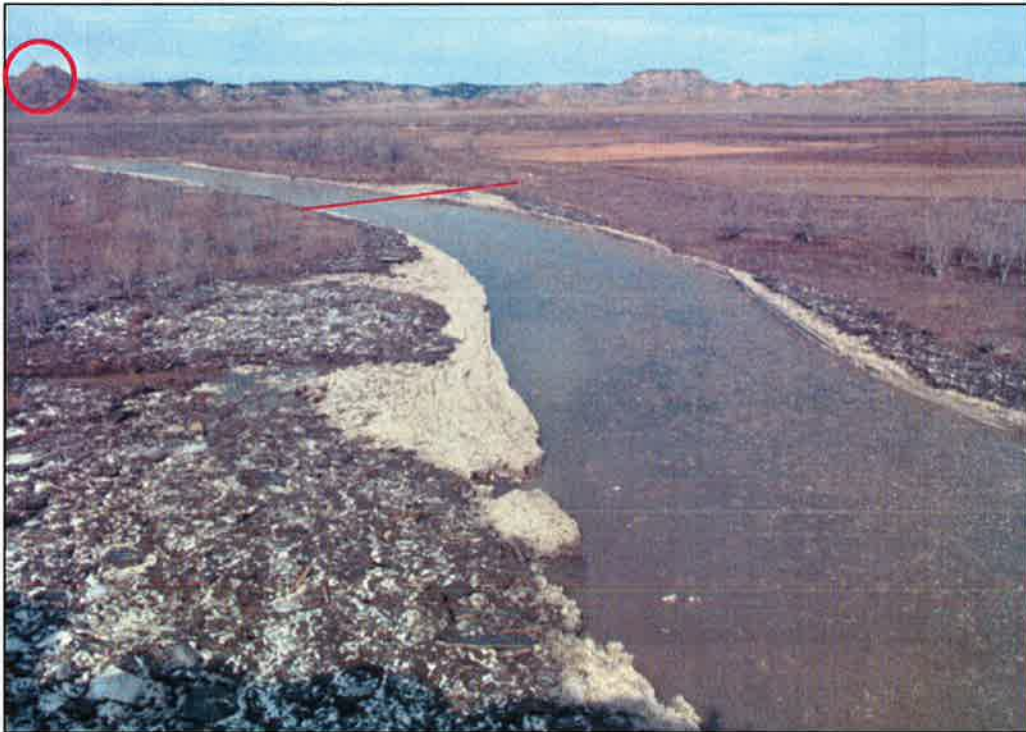
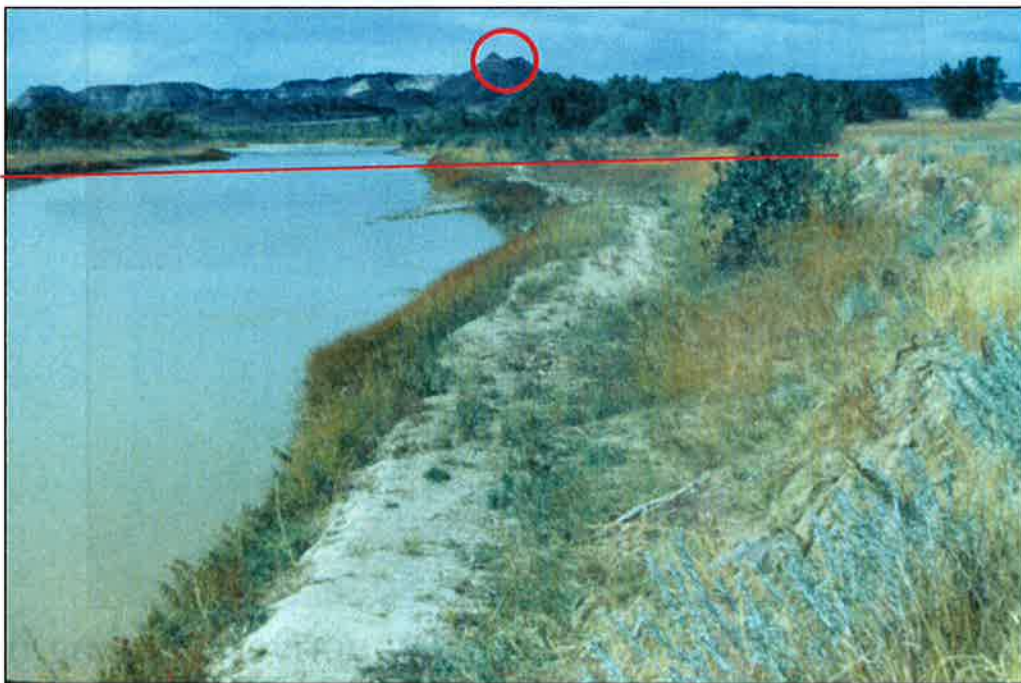
PR151. **Top.** 11 March 1995. View upriver with ice on floodplains. Red line is approximately on line of section. **Bottom.** 27 September 1995. View upriver. Red line is the approximate line of section. Crest of berm of newly (1995) deposited sand crosses the section at station 36. The same 'twin' butte is in the red circle in both photographs.

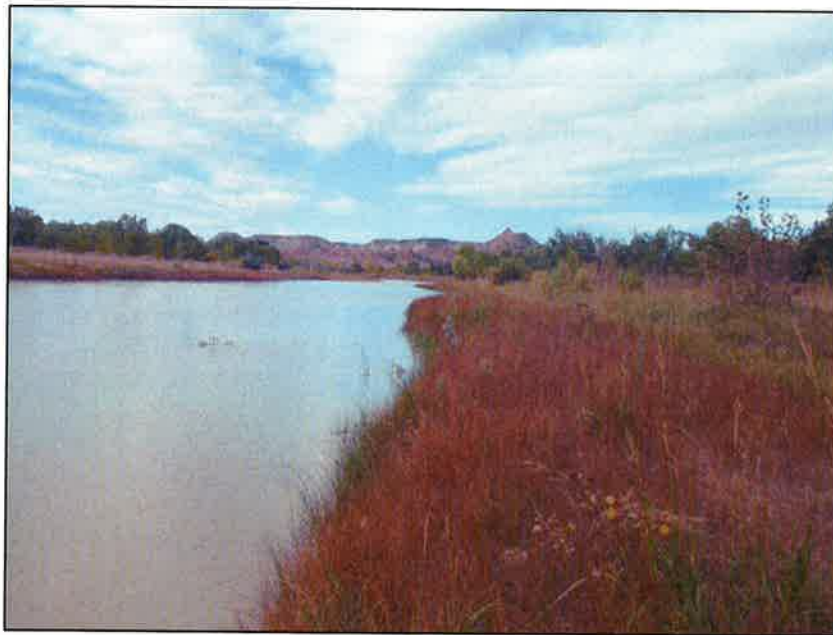
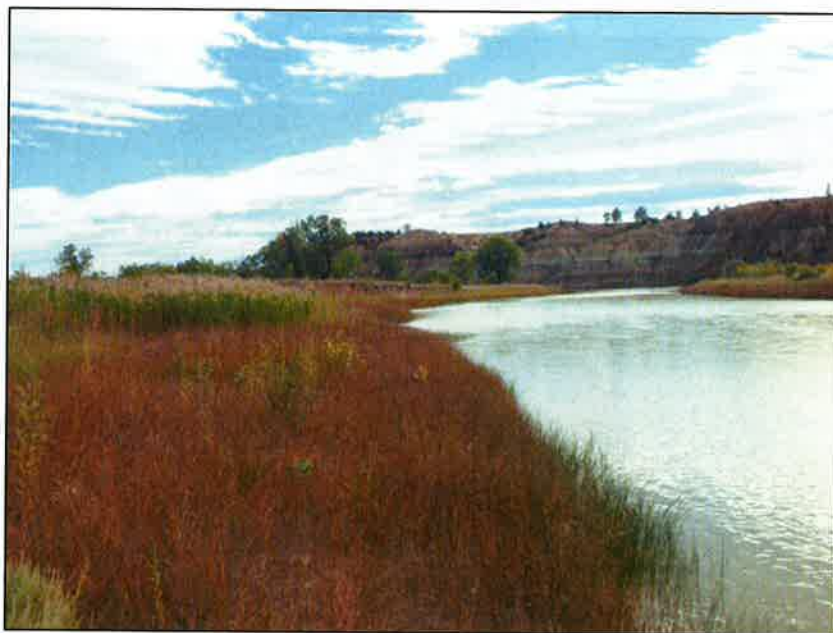
PR151. **Top.** 30 September 2013. View upriver standing on the line of section at station 43. The predominantly red vegetation is sedge (*Scirpus spp.*) growing closest to the water on a 'bench' below the level of the inset flood plain (green color). (see Moody et al., 1999, Ontogeny of a floodplain, GSA Bullentin 111(2), 291-303). **Bottom.** 30 September 2013. View downriver standing on the line of section at station 43. Red vegetation is sedge (*Scirpus spp.*).

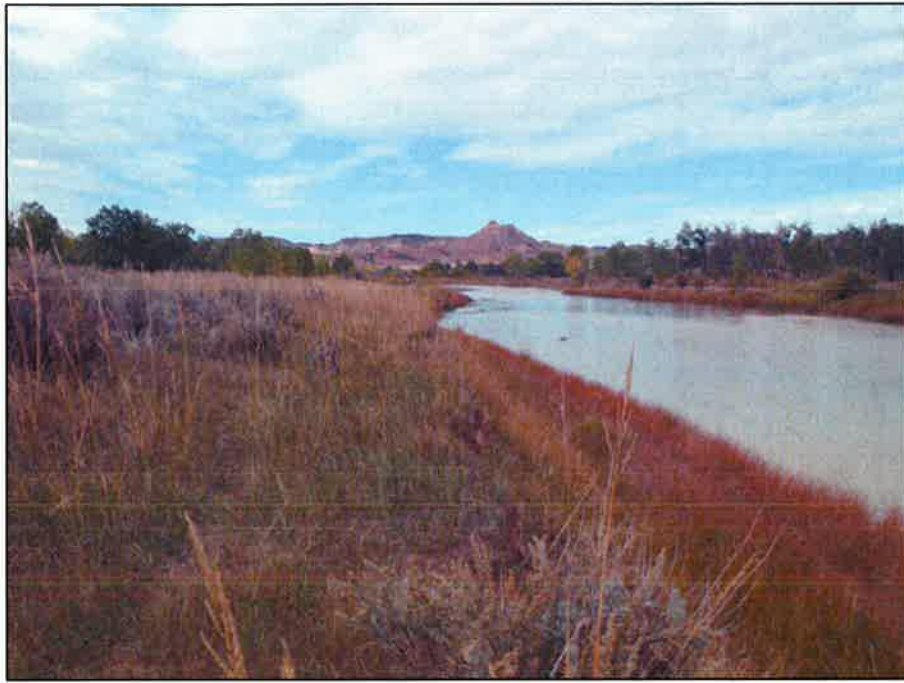
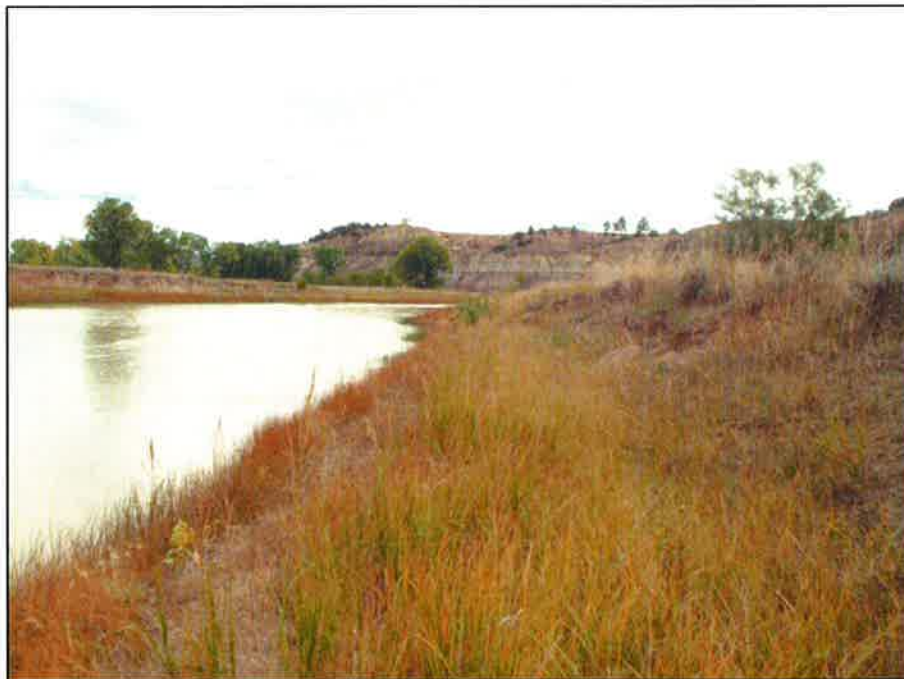
PR151. **Top.** 30 September 2013. View upriver standing on the line of section at station 86. The predominantly red vegetation is sedge (*Scirpus spp.*) growing closest to the water on a 'bench' below the level of the inset flood plain (green color)--see plots in data file. **Bottom.** 30 September 2013. View downriver standing on the line of section at station 86.
